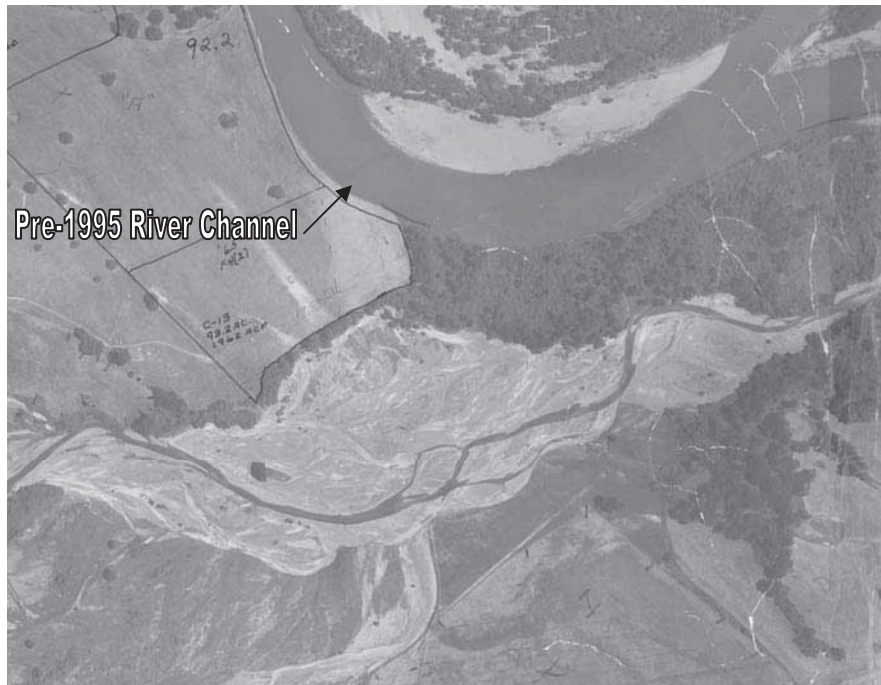
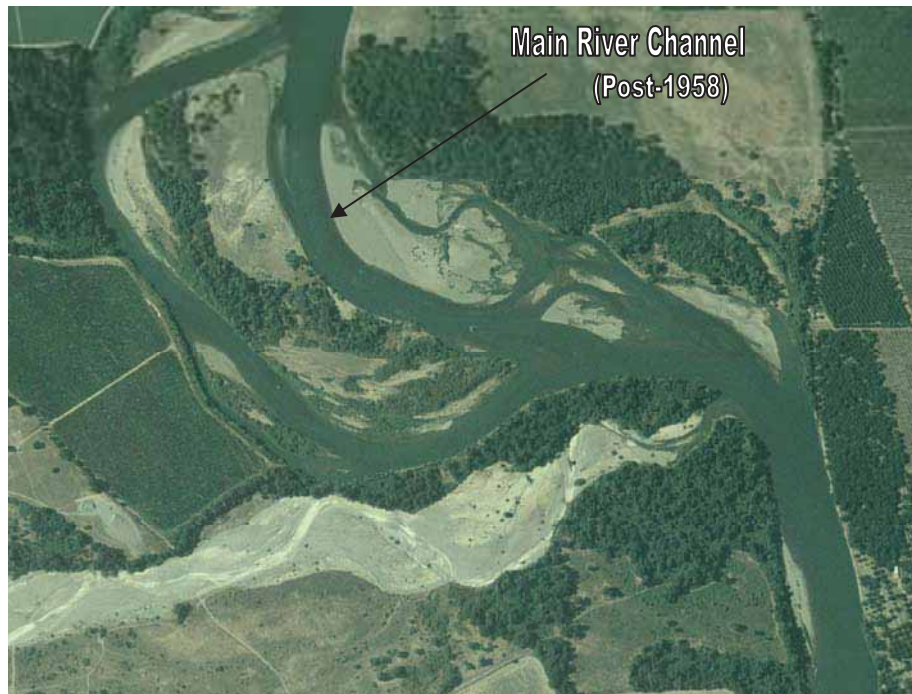
Image Comparison 4a. Thomes Creek confluence with the Sacramento River (delta) in 1952 (top) and 2004 (bottom). Note that Thomes Creek's mouth may be migrating further to the north, eliminating riparian forest along the Sacramento River and cutting off the 1952 river channel. In the late 1990s a new river channel formed by cutting through the large point bar and it is possible that the island created will become attached to the western land mass.

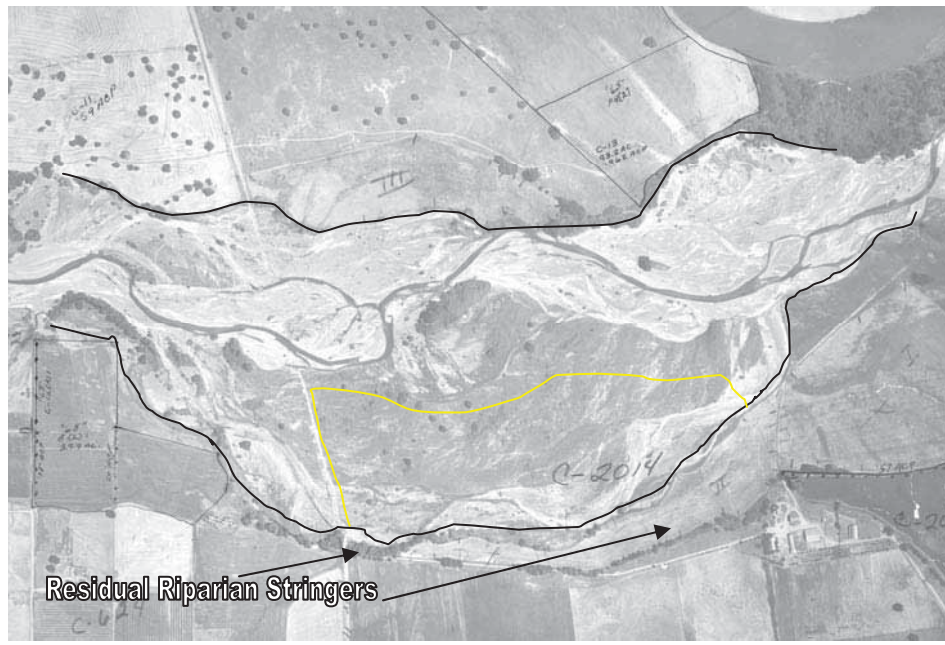
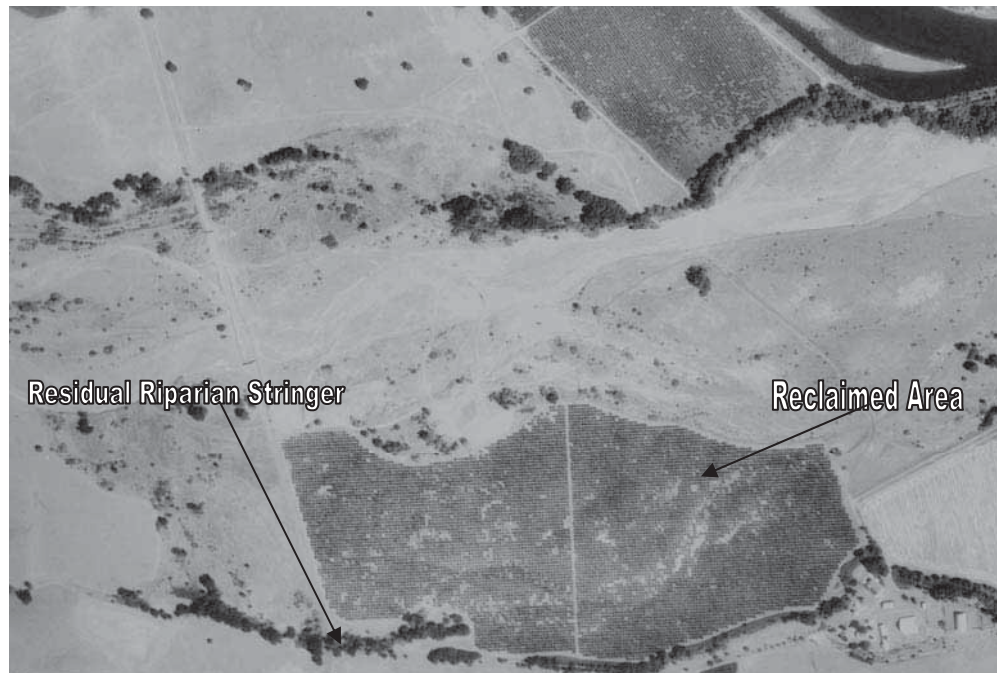
- Thomes Creek is wide and has a highly braided character through the entire assessment area. Total stream channel width was often in excess of 1,000 feet, while at both the Hall Creek low-water crossing (see Image Comparison 4b) and Interstate 5 crossing site (see Image Comparison 4c) total stream width was about 3,000 feet.

- Streamside vegetation is very sparse and only exists as small "islands" of short-statured growth within the channel boundaries and as stringers of moderate to large canopied trees along the external edges of the stream channel. Frequently these stringers of hardwood trees are associated with cut bank features (see Image Comparison 4b).

- Thomes Creek continues to be highly braided throughout its reach; however, in many locations its 1952 width has been constricted. Examples include: the Hall Creek crossing (see Image Comparison 4b); levees constructed to protect the Tehama-Colusa Canal; and the Interstate 5 crossing (see Image Comparison 4c). In the latter case the original width was narrowed from 0.6 miles to less than 0.3 miles.

Image Comparison 4b. Thomes Creek at the Hall Road crossing in 1952 (top) and 1994 (bottom). Note the extent of the stream's overflow patterns in 1952 (black lines) and the rows of riparian trees along the outer stream banks. By 1994 significant portions of the overflow channels have been converted to agricultural land (area encircled by yellow line), which is orchard. Note the row of hardwoods still existing along the stream bank feature south of the orchard.

- Many levees have also been constructed between Interstate 5 and the Sacramento River.
- Riparian vegetation has changed. At the stream's confluence with the Sacramento River the riparian forest along the northern portion of the delta has narrowed. Riparian vegetation continues to be scant and patchy in 1994; however, dense growth occurs within some reaches (particularly immediately upstream from Richfield and immediately upstream from Interstate 5; see Image 4d). It is likely that most of this vegetation is comprised of invasive species.
- Historical outermost stream channel banks can still be identified by their residual hardwood stringers of moderate to large size trees; however, these features are often a distance from the current stream channel (see Image Comparison 4b).

There are many locations where the stream's 1952 flood overflow channels have been reclaimed to agriculture. Examples include locations at the Hall Road crossing (see Image Comparison 4b) and the Interstate 5 crossing (see Image Comparison 4c). Similarly as described for the Red Bank and Elder Creek cases, the reclaimed sites retain the old stream bank cut features with narrow stringers of hardwood trees. These features are now often quite distant from the stream channel.

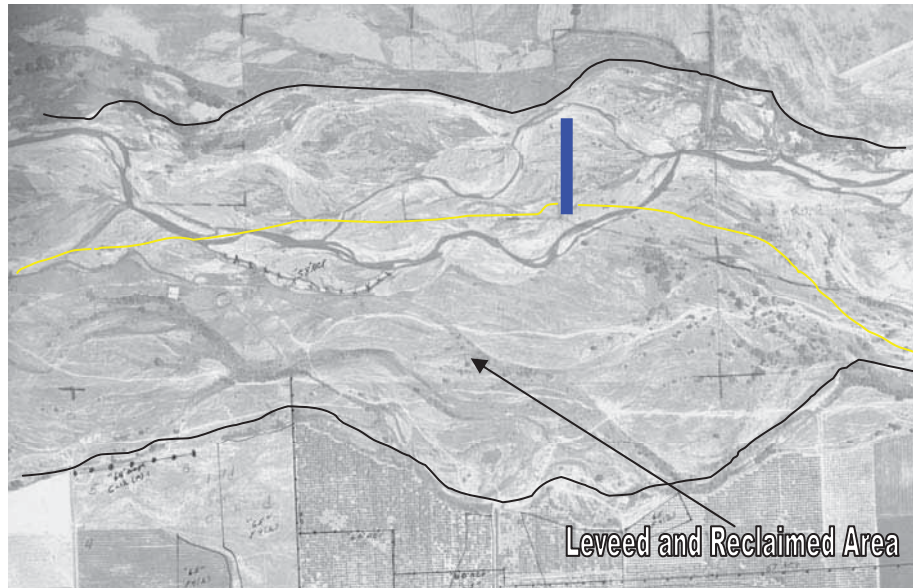
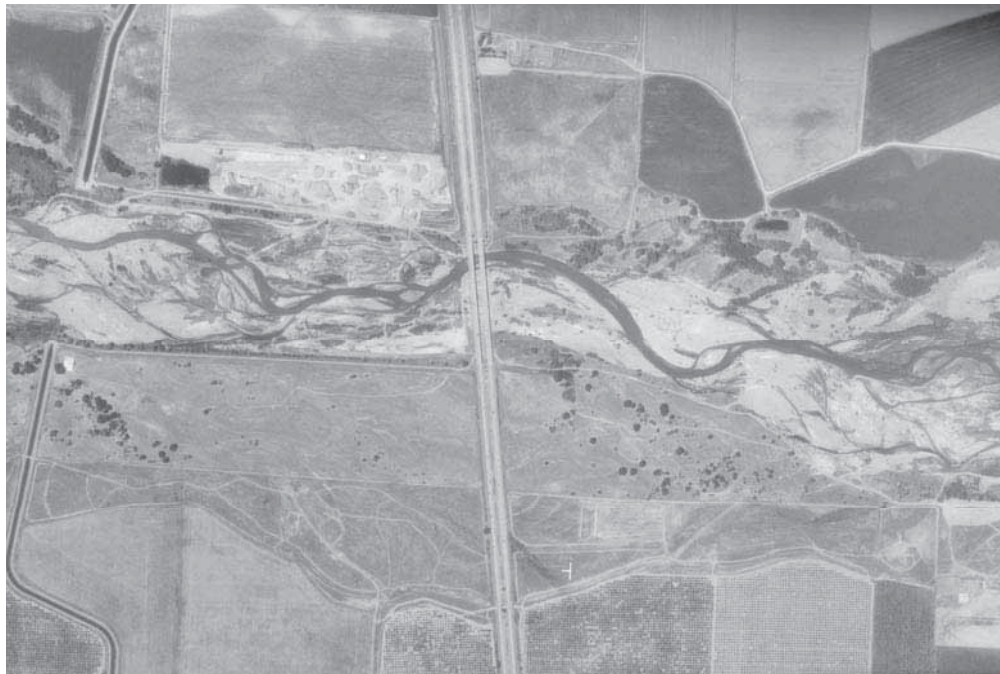
Image Comparison 4c. Thomes Creek at the Interstate 5 crossing site in 1952 (above) and 1994 (bottom). Note the braided stream condition in both images. The Interstate 5 Bridge locations and lengths are shown as a blue bar. The extent of overflow patterns in 1952 are shown by the black lines and the 1994 extent of stream constriction is shown by the yellow line. Comparing these images show the extent of channel constriction. (The feature to the west of Interstate 5 is the Coming Canal crossing.)

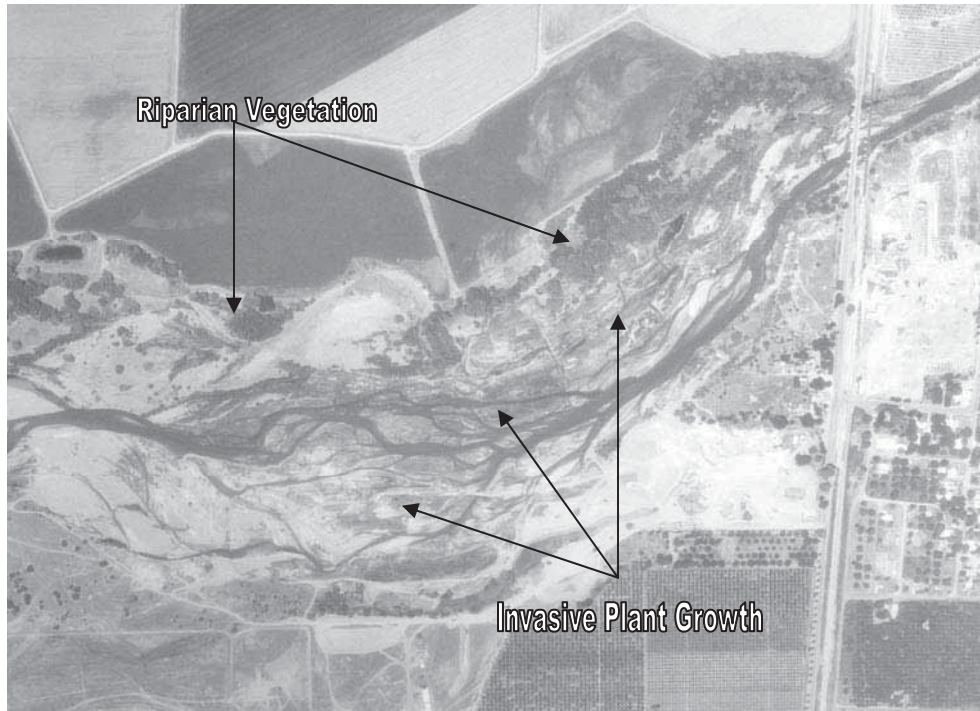
Image 4d. Thomes Creek immediately west of Richfield, in 1994. Note the vegetation occurring within the stream braids, likely *Arundo*, and larger-statured vegetation along the sides of the channel.

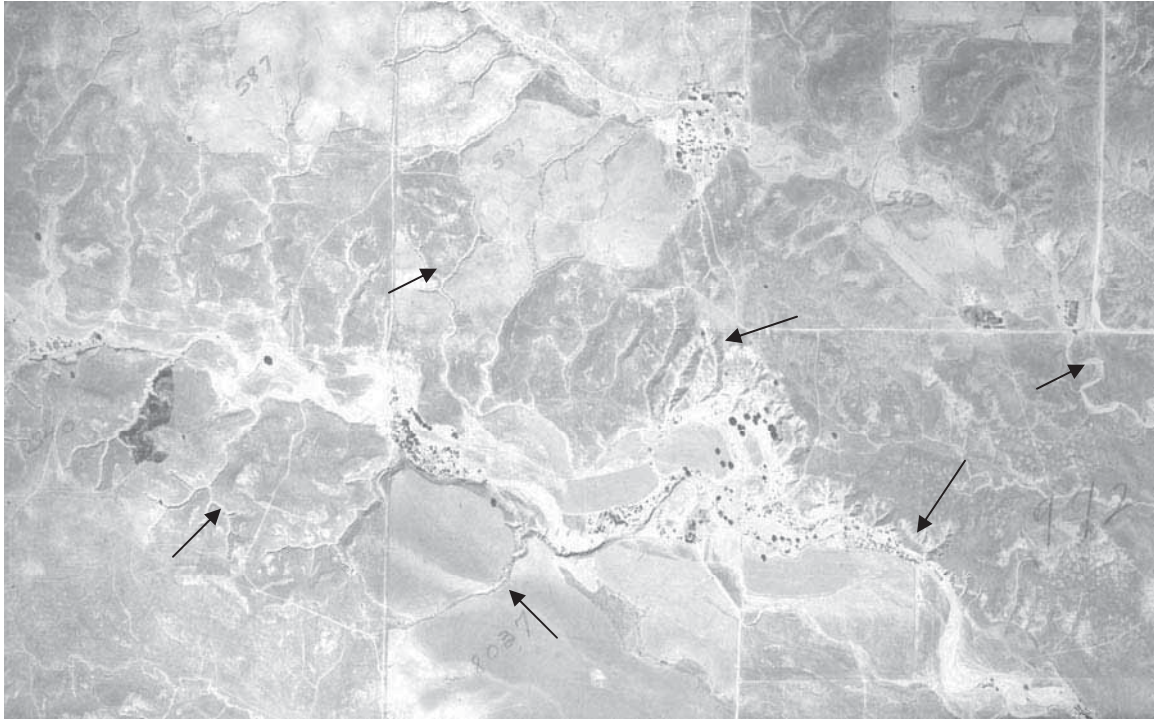
The 1938 photograph of this portion of the Brickyard Creek drainage shows a large number of sharp erosion features, apparently recent in origin. These include steep and raw cutbanks in minor gullies draining into Brickyard Creek. Many of these erosion features are dendritic, suggesting downcutting in the main channels, leading to downcutting in the feeder channels.

Riparian growth is scant, only occurring along Brickyard Creek's main channel in a few scattered locations. The land use is rangeland in the north of the image with some dry land agriculture south of Brickyard Creek.

In the 2004 photograph (Image 5b) several features are immediately apparent—a 2004 rangeland fire has burned through the western portion of the assessment area and urban sprawl has pushed in from the east (suburbs of Red Bluff). In addition, several dams have been constructed in small draws, creating slender ponds.

The sharp erosion features noted in the 1938 photograph appear muted in the 2004 image. Although the resolution of the 1938 image is greater than the 2004 photograph, this change appears to be a product of gradual healing of the eroded gullies and suggests that the distinctive features seen in 1938 were created only shortly prior to when the photograph was taken.

Riparian vegetation appears to have changed little in extent or density between 1938 and 2004. Very little if any riparian growth is seen in 2004 adjacent to draws or gullies leading to Brickyard Creek and Brickyard Creek has only insignificant amounts of growth in small patches.

Image 5a (1938, above) and 5b (2004, below). Upland Site 1, Brickyard Creek, West of Red Bluff. Examples of sharp erosion features are pointed at by the arrows.

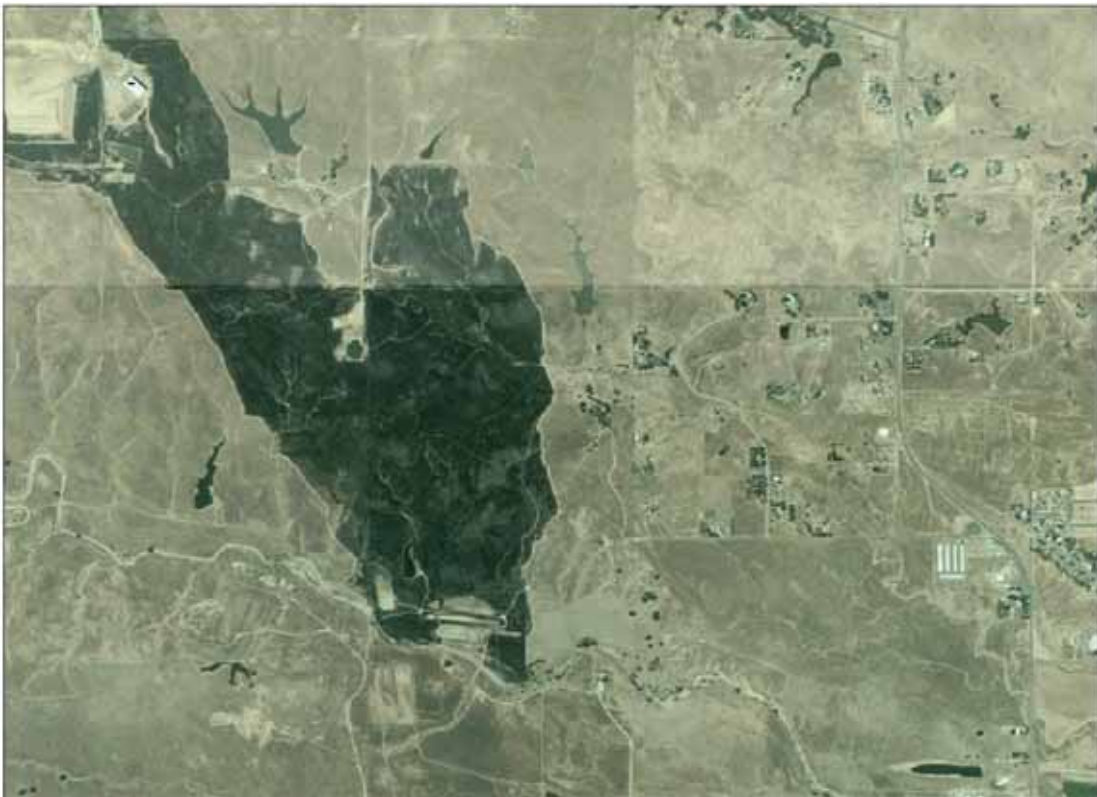
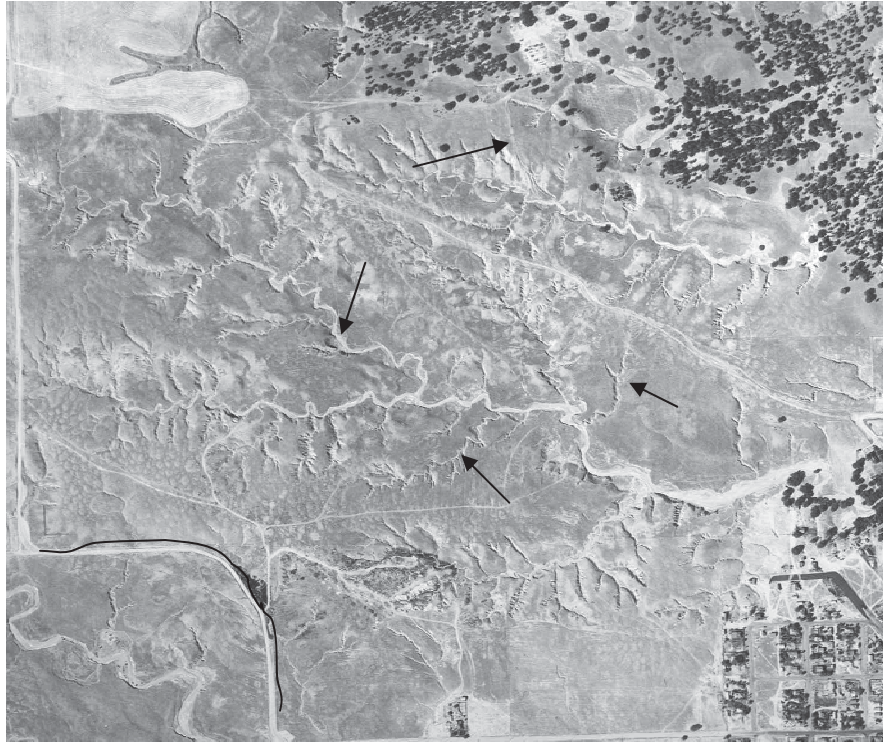
In 1938 this assessment area is laced with sharp, down-cut gullies. No urban development has occurred in the area and vegetation appears to be grassland/rangeland. No riparian vegetation exists in any of the gullies leading into Brewery Creek or along the main creek itself.

In 2004 residential areas have extended westerly from the City of Red Bluff along both Park and Waldbridge Streets. Waldbridge Street has been extended through the southern portion of the assessment area but the central portion of the assessment area has been avoided by new development, likely due to the eroded and broken terrain. As in the case of Site 1, the sharp erosion gully features are much less apparent in 2004 than in 1938, suggesting that they have rounded and begun to heal. As in 1938, there is no riparian vegetation along the gullies or Brewery Creek. Also, the assessment area continues to exist as a grassland/rangeland.

Image 5b (top, 1938) and 5b (bottom, 2004). Brewery Creek Drainage, immediately northwest of Red Bluff (Site 2). Examples of sharp erosion features are pointed at by the arrows. For reference, the bend of Baker Road is shown as a black line in both images.

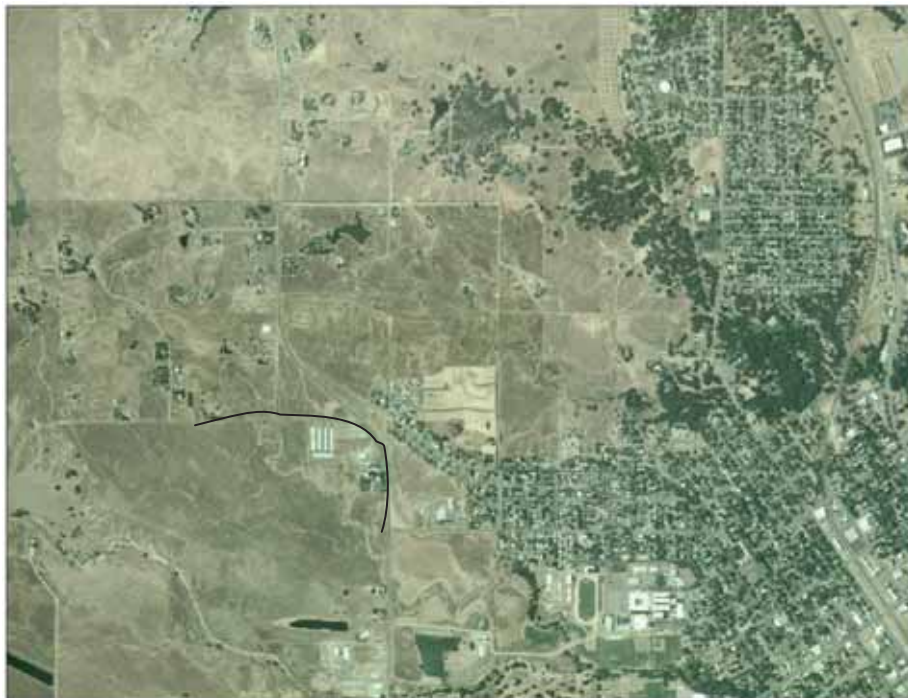
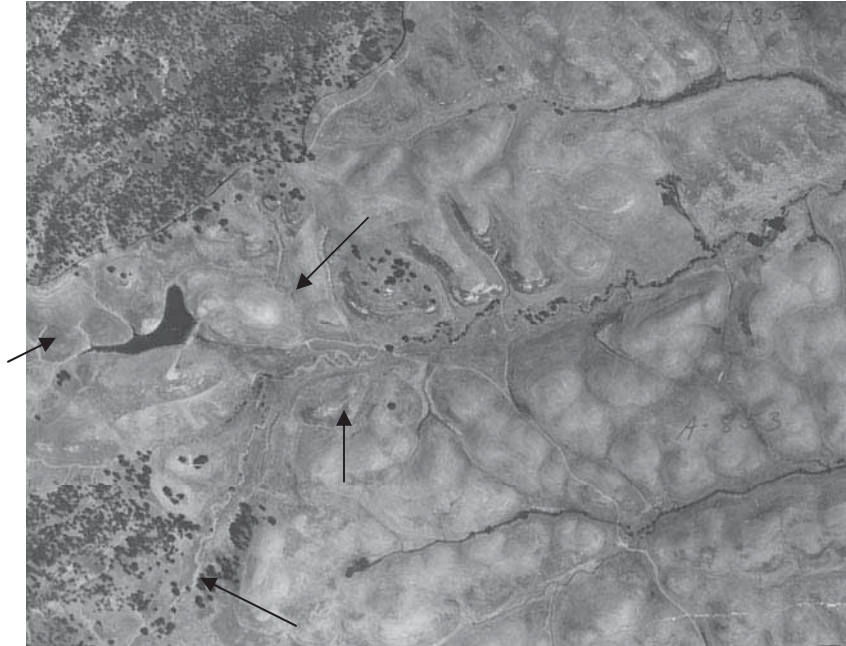
As shown by Figure 6a, in 1952 this assessment area is composed primarily of gently sloping and rounded terrain. Dry land agriculture is used on most of the land, except for the draws with steeper slopes and the hills to the northwest. The hills have moderately-heavy growth of gray pine and blue oak.

Sharp erosion features exist at Site 3, in a similar manner to Sites 1 and 2. Riparian growth is very restricted, only occurring in narrow, disconnected patches directly adjacent to Oat Creek and its larger tributaries. Riparian growth does not exist along any of the smaller gullies.

By 2004 (Figure 6b) some changes are apparent, relative to 1952. First, the oak/pine woodland north and south of the pond has been significantly thinned but not eliminated. Second, the erosion features sharply seen in 1952 appear to be more rounded and blend in with the adjacent uplands. Third, dense vegetation has encircled the pond, with some of the growth being emergent. It is possible that the pond's size has declined, due to sediment deposition, or that the emergent vegetation contributes to this perception. Riparian growth along Oat Creek is even more limited in 2004 than 1952. Riparian stringers do not exist in 2004, merely scattered individual shrubs or shrub-clusters.

Figure 6a (top, 1952) and 6b (bottom, 2004). This assessment area (Site 3) is located along Oat Creek, approximately 2 miles south of the location called Red Banks. Significant erosion features are shown by arrows.

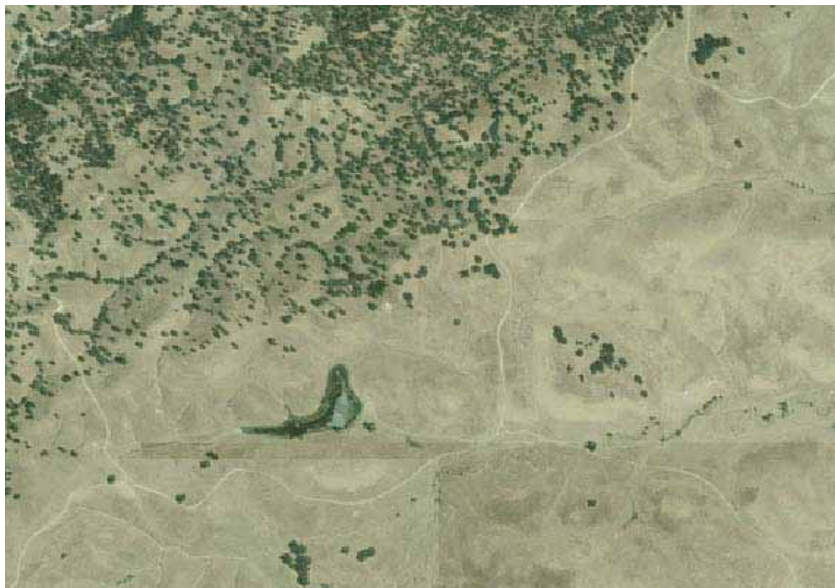
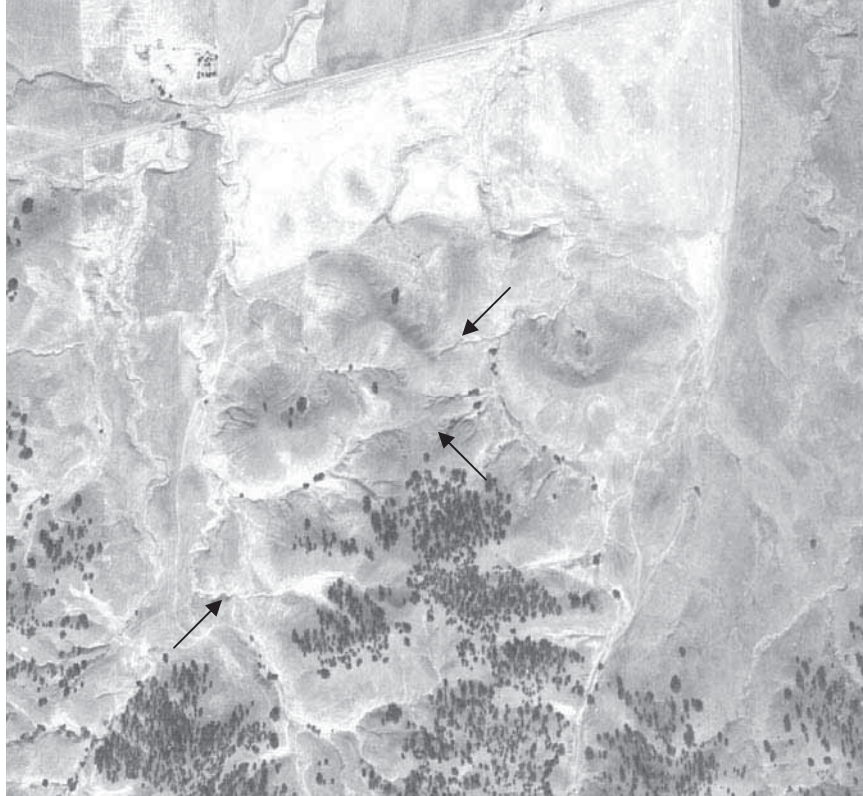
The vicinity southwest of Paskenta, shown in Figures 7a and 7b show similar erosion features in small headwater gullies and along bends of stream channels, in a manner similar to Sites 1-3. However, the gullying is less severe and less wide-spread than in the previous assessment areas.

Figure 7a (top, 1938) and 7b (bottom, 2004). This area (Site 4) is located only 1 mile southwest of Paskenta. Sharp erosion features are shown by the arrows.

In 1938 the area was a combination of grassland/rangeland on the flats and gentle slopes with stands of gray pine and blue oaks on the steeper, adjacent hills. Riparian vegetation does not exist on any of the gullies. In 2004 the gully erosion is less pronounced but riparian growth still is totally lacking. The pine and oak woodlands are similar in extent and density, with no evidence of thinning.

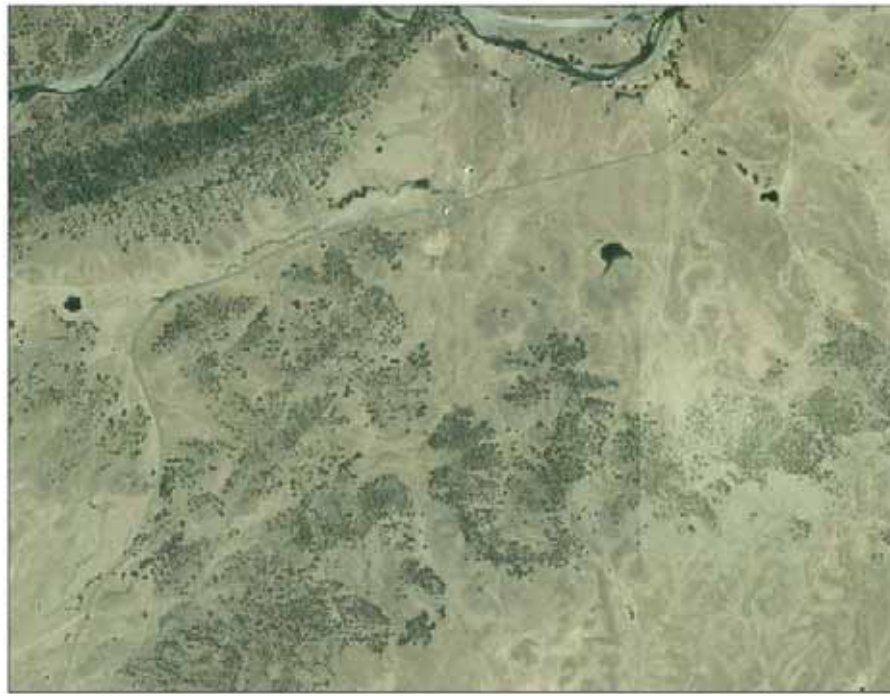
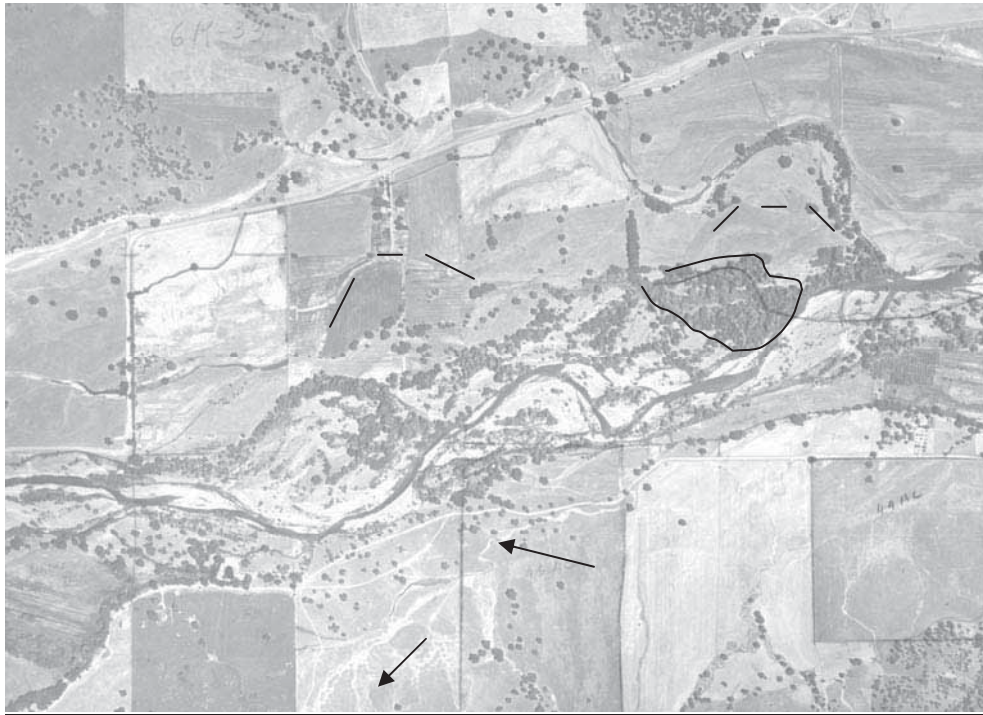
Figure 8a (top, 1952) and 8b (bottom, 2004). Significant areas of riparian growth that have been affected are circled by black lines. Gully erosion features are shown with arrows. Note old stream bend features shown with broken lines. This is Site 5.

Figures 8a and 8b compare a location along Thomes Creek approximately 1 mile west of Flournoy. Fields adjacent to Thomes Creek were irrigated in both 1952 and 2004 but further away from the stream the lands are grasslands. Several small ponds were constructed prior to 1952 in the hills immediately south of the assessment area, no doubt to help in irrigating adjacent fields.

Some gully erosion can be seen in Figure 8a; however, the degree of upland erosion is less than in Sites 1-3.

Riparian vegetation shows significant change between 1952 and 2004. Specifically, Thomes Creek has eaten away at large portions of the riparian habitats that existed in 1952. Evidence of past stream bends, extending hundreds of feet to the north of the existing Thomes Creek channel, can be seen on both photographs. This suggests that the stream has varied in width and path in the past. Even so, the amount of riparian cover along the lower portion of McCarthy Creek, in the northeast quadrant of the 1952 image, is very similar in both years. In both 1952 and 2004 riparian vegetation and other shrub or tree cover is very sparse along gullies feeding into Thomes Creek.

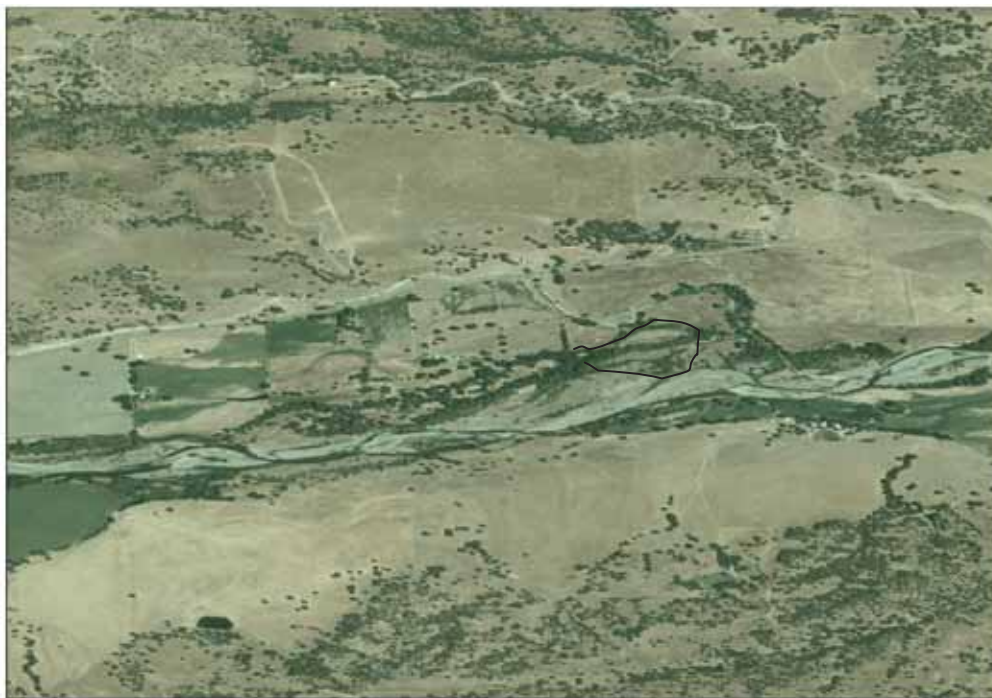
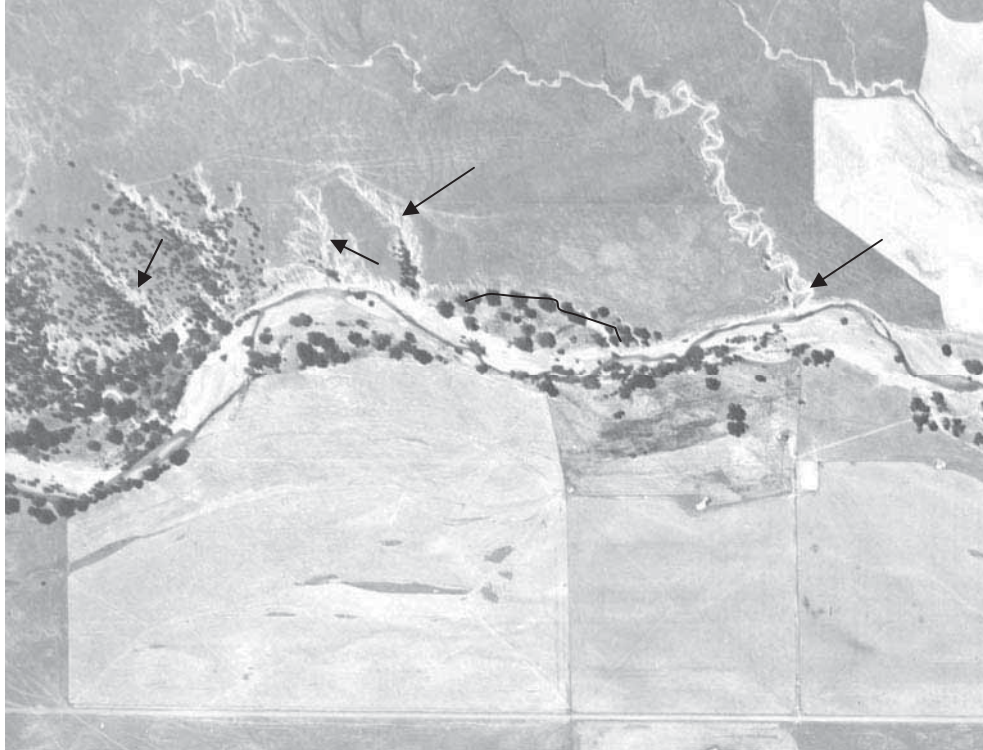
Figure 9a (top, 1947) and 9b (bottom, 2004). This is Site 6, along Elder Creek and approximately 1 mile west of the Paskenta Road. Note significant erosion features shown by the arrows. An old stream erosion feature is shown with the wavy line.

Along the northern bank of Elder Creek there are a number of significant erosion features, similar to what was seen in Sites 1-3. Sharp cut banks exist in the 1947 photograph, along with dendritic gully erosion patterns (as shown on Figure 9a). Riparian growth is very scant along Elder Creek and not present in side gullies.

In 2004 the erosion features appear less noticeable than in 1947, with the possible exception of the gully shown by the furthest east arrow on Figure 9a. Riparian growth - all of which exists directly along Elder Creek - appears mostly unchanged between 1947 and 2004. Finally, agricultural efforts appear to have been curtailed south of Elder Creek between 1947 and 2004, with only grasslands/rangelands south of Elder Creek during more recent years.
