**VIDEO WEIR TECHNOLOGY PILOT PROJECT
FINAL PROJECT REPORT
2007– 2010 FALL CHINOOK SALMON ESCAPEMENTS
COTTONWOOD, COW AND BEAR CREEKS,
SHASTA AND TEHAMA COUNTY, CA**

By
Michael C. Grifantini, Gail Grifantini,
Ryan Teubert, Rachel Aschbacher and Mary Mitchell

Western Shasta Resource Conservation District
Anderson, California
2011

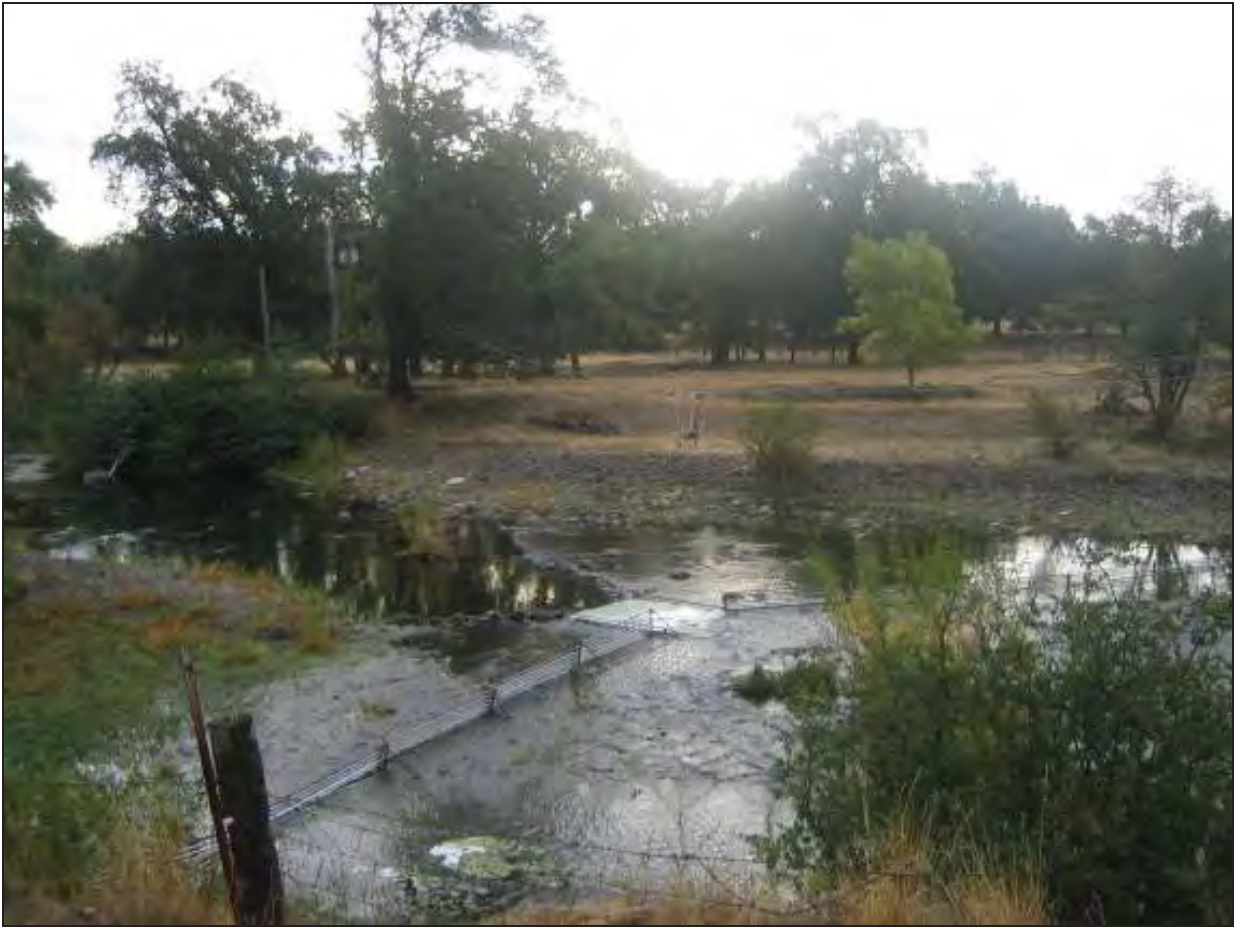
Figure 5. Bear Creek video station power supply box. Cables were used to suspend the camera directly over the weir's fish passage opening. The equipment lock box was located to the right (not shown).

The three video stations were located near a conventional “on-grid” power supply and, if necessary, a 120-volt transformer was installed to run the camera, lights, and equipment. Wiring was run from the power supply to the cameras and recording equipment. An accessible equipment lock box was set up to keep recording equipment safe from weather and vandalism. An in-line Ground Fault Interrupt Circuit (GFIC) device provided an automatic shut-off for the system should the power supply short out or contact any water.

A back-up power supply provided power for a 1-2 day period should an outage occur in the regular power supply (consisting of 6 linked 6-volt batteries provided a 12-volt DC power supply to a conventional computer battery backup system).

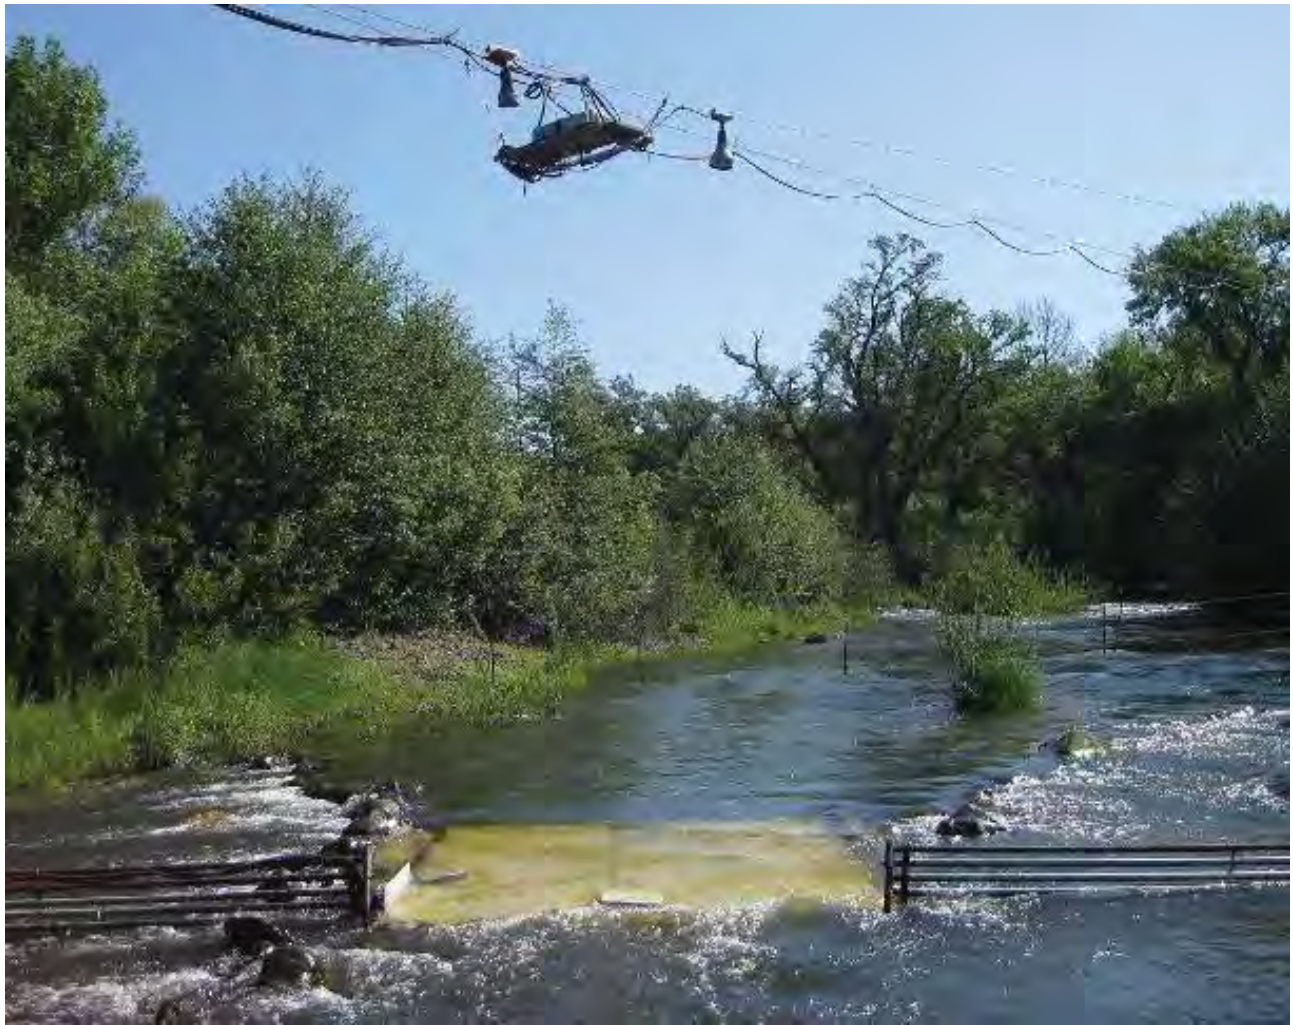
Figure 6. Camera box suspended over Bear Creek, looking upstream. Shown are three underwater cameras, the overhead camera, and the weir opening allowing fish passage.

The camera box was attached by ropes to the main cables, which reduced vibration caused by wind. Power cords and a camera co-axial cable were wired to an overhead support cable with short plastic coated utility wire and connected inside the station's DVR-battery box. Figure 7 shows the refurbished refrigerator used to secure and shelter the station's video equipment, electrical accessories and batteries.

Lighting for the video cameras was provided by two compact outdoor fluorescent spotlights mounted on the overhead cable system (visible in Figure 6). A photocell sensor, similar to those used on streetlights, turned the lights on at dusk and off at dawn. Crews checked the lights for proper operation by reviewing video footage from the previous morning during their daily weir maintenance.

Weirs were designed and constructed to channel salmon into the camera's view without causing passage delay (Figure 6). The weirs were constructed of 10-foot x 1 1/8 inch steel pipes welded to uprights with 3-inch spaces between the pipes. Taller panels used 1 1/4 inch EMT conduit on the inner cross-members to lighten the overall weight of the finished panel. The horizontal pipe panels were designed to fit the depth of the creek at the weir site, e.g. panels in shallow water had only two or three cross members while panels in deeper water had more. The horizontal design and spacing between bars of the weir panels allowed leaves and sticks to pass downstream while preventing salmon from passing the weir unmonitored. Panels were secured with rebar stakes and specially designed "dog leg" fittings. The rebar stakes were driven vertically through the panel uprights and into the stream bottom. The dog leg fittings were bolted to the uprights and a "weir arm" was slid through the fitting and pounded into the stream bottom at a 45 degree angle downstream (Figure 9).

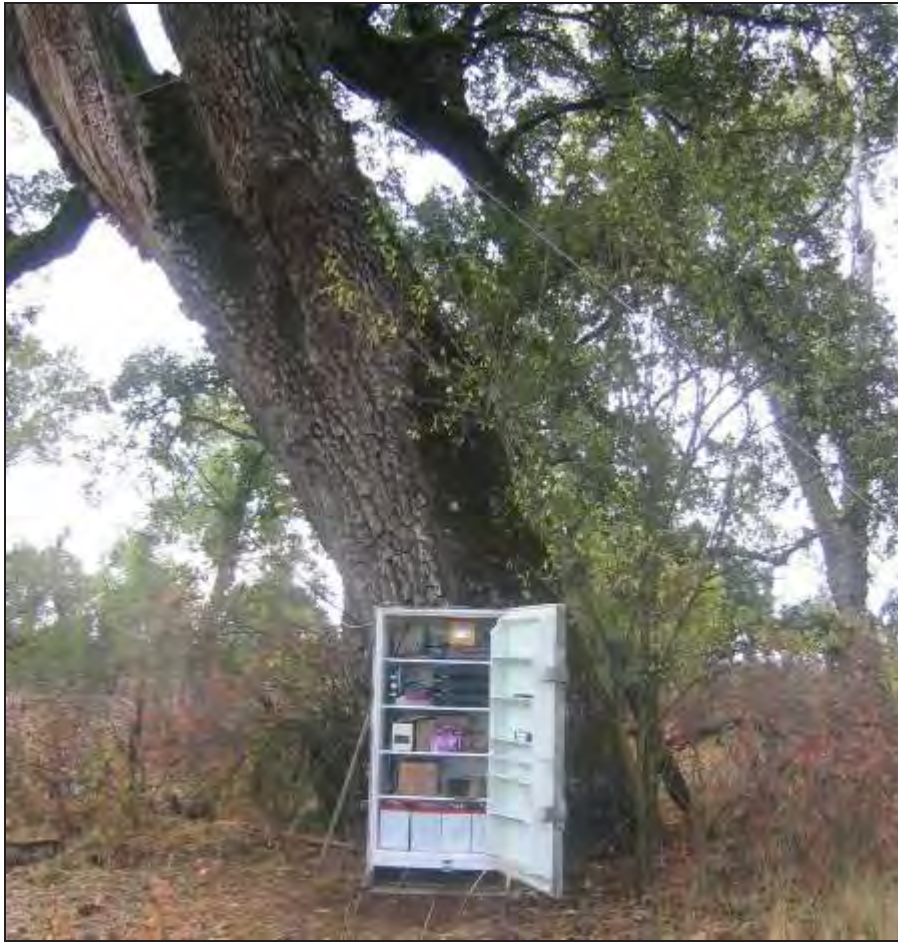
Figure 7. The modified refrigerator contained the DVR's, power controls, equipment and storage boxes, monitor and batteries. The cable above the lock box is the anchoring cable to the two main cables suspending the camera over the creek.

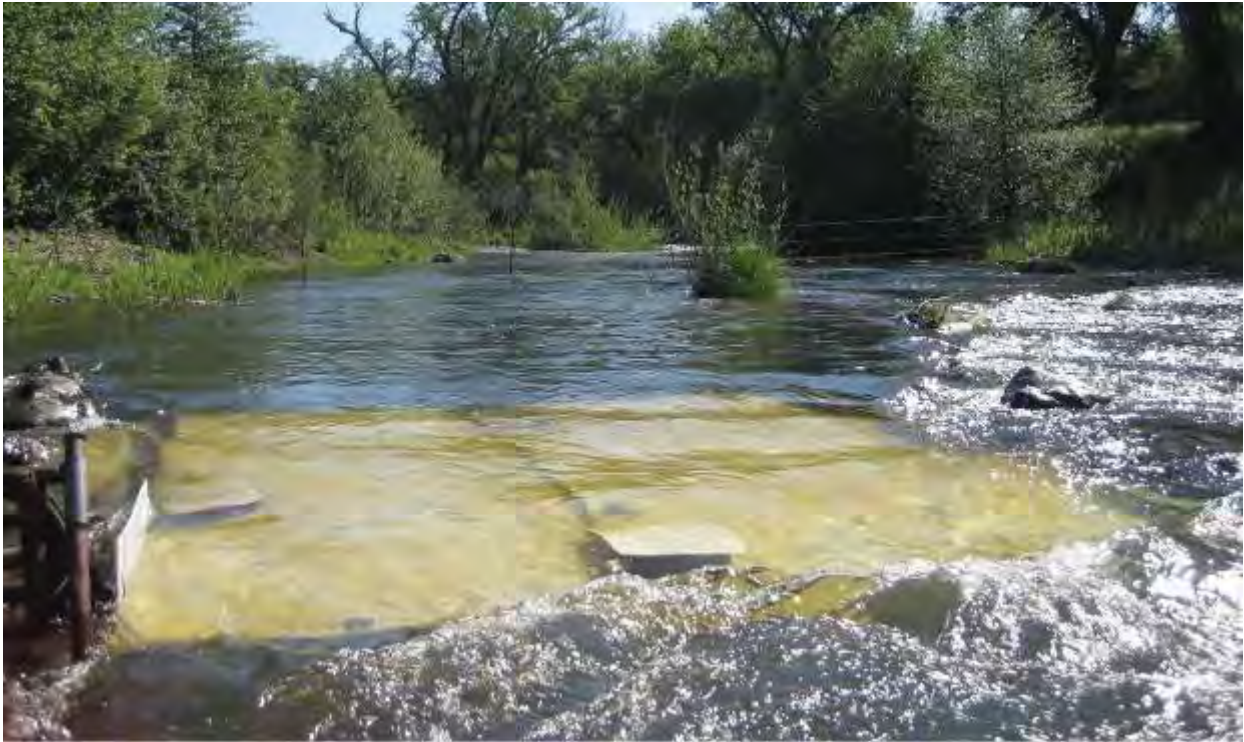
Figure 8. The underwater cameras were useful for monitoring up and down stream movement as well as species identification. The two cameras in the middle have a sideways view.

The underwater camera system was developed and refined over the years and became a standard tool in late 2008. In prior years the cameras were used sporadically and were not placed in standard locations. Since late 2008, three underwater cameras were typically installed on the white weir plate (background plates). The cameras could be color or black and white, depending on the objective at the time of set-up. Two cameras were installed in the middle near the lower edge of the plate and the view set to look across the plate for a side view of passing fish. White panels were installed along the sides so the fish would be silhouetted against a light background. The third camera was installed near the top of the weir plate to one side to look across the whole weir plate (Figures 6 and 8). The underwater cameras monitored upstream and downstream movement. The use of color cameras provided an additional means of identifying fish based on distinguishing color patterns, but the best color information was available only in bright light conditions. In low light levels, such as night time, the camera merely recorded a black and white image.

The cameras were protected inside a custom-made high grade PVC water-proofed capsule. The capsule was strapped to a 20-pound metal plate that was anchored in the creek bed to withstand any pressures from the current. The camera's video and power cable ran atop the weir panels, and once away from the creek, it was buried underground from that point to the lock box to deter vandalism.

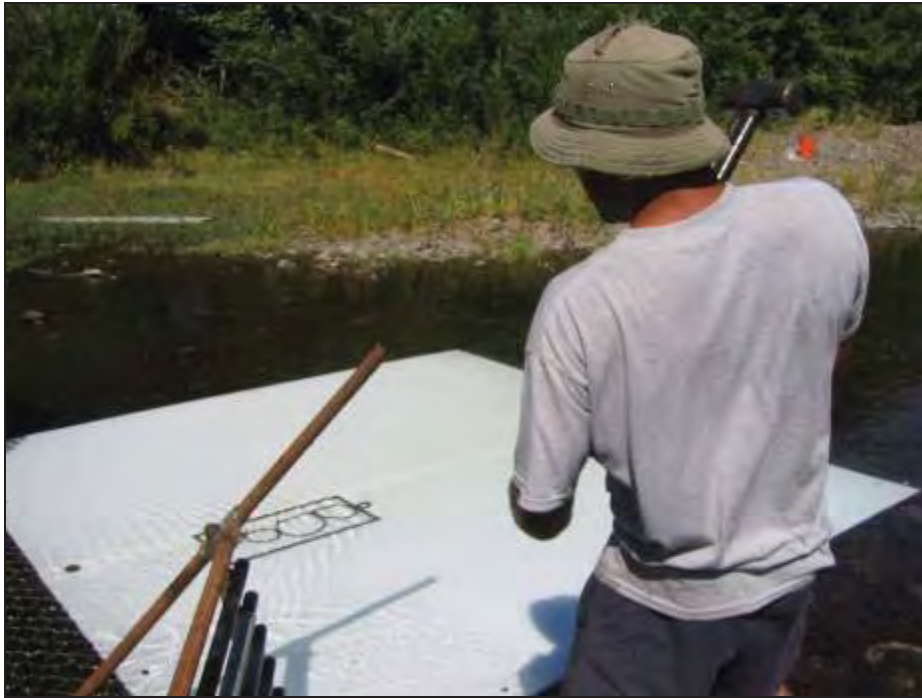
Figure 9. Construction of the weir. Dog leg fittings were bolted to the uprights and the “weir arm” slides through the fitting and was pounded into the stream bottom at a 45 degree angle downstream.

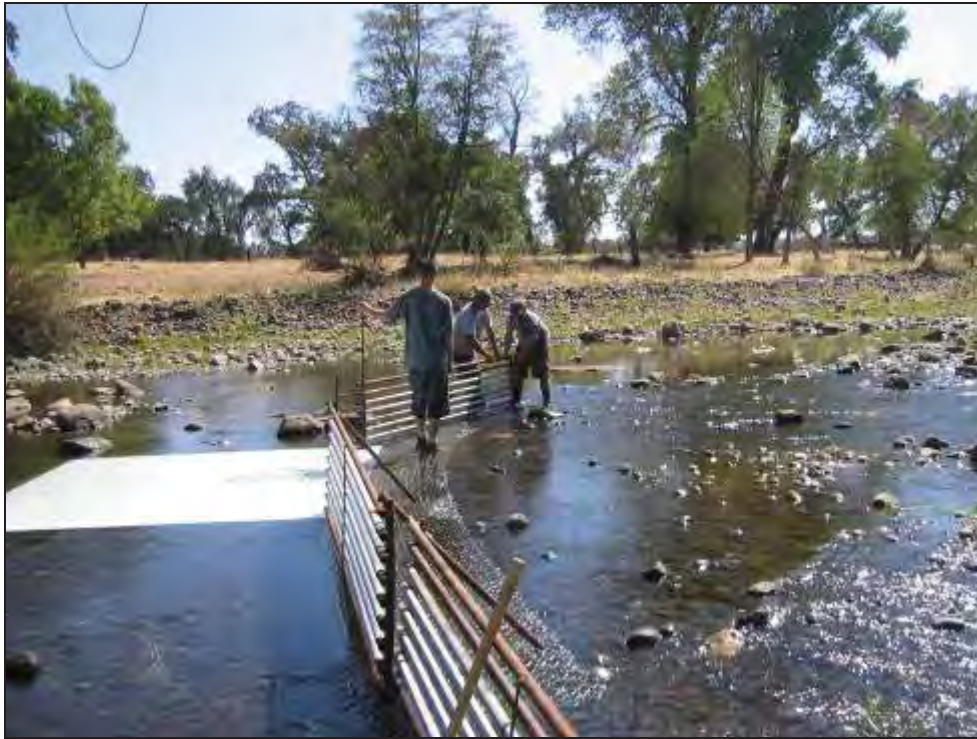
Figure 10. Construction of a weir included white high density polyethylene (HDPE) sheets staked to the creek bottom to make the observation of passing salmon easier.

White high-density polyethylene (HDPE) sheets were staked to the creek bottom below the overhead camera to create a background to improve viewing of the passing fish (Figure 10). The sheets had $\frac{3}{4}$ -inch holes drilled around the perimeters to allow staking and a metal frame plate was bolted to the upstream edge of both sheets prior to placement in the creek. Twenty-four inch concrete form stakes, with a 2-inch washer welded to the top, secured the sheets.

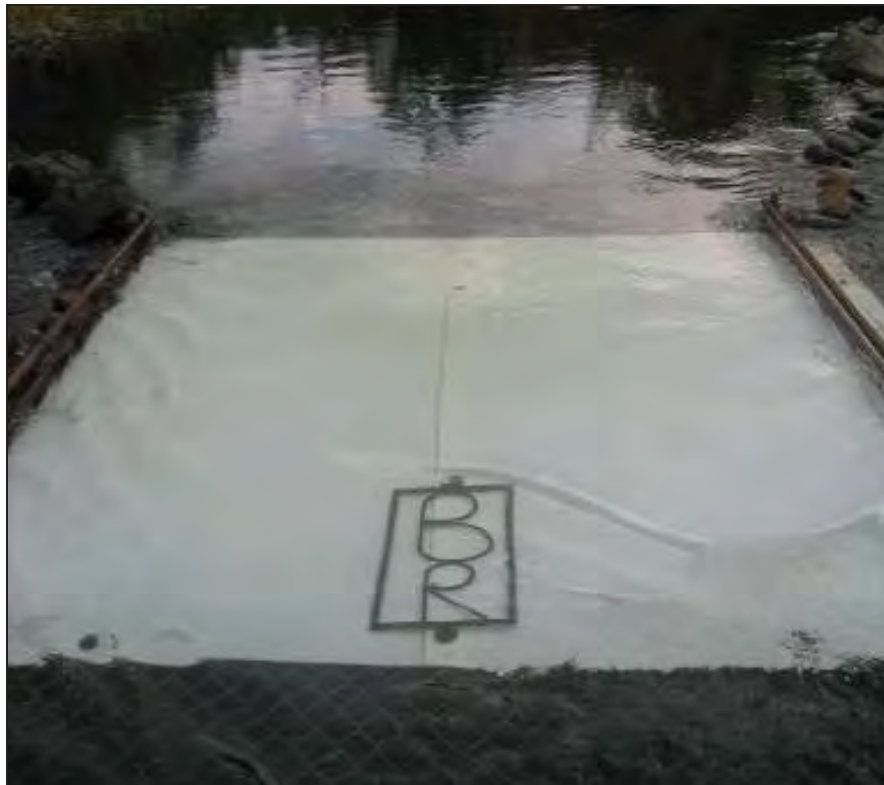
Figure 11. Two weir panels were added to the fish passage opening to prevent fish from skirting around the ends of the weir. A metal rectangle measuring 24 x 12-inches allowed tape readers to approximate fish lengths as well as identify the creek: BR= Bear Creek.

Two weir panels were placed along the outside edges of the white bottom plates just above the water surface. These guidance panels at the fish passage opening prevented fish from skirting around the ends of the weir (Figure 11).

A metal rectangle measuring 24-inches long by 12-inches wide was attached to the sheets allowing tape readers to approximate fish lengths (Figure 11). This rectangle was also designed with a custom welded “station brand” in the center. While viewing, tape readers were able to identify individual creek footage by the brand: BR= Bear Creek (Figure 11).

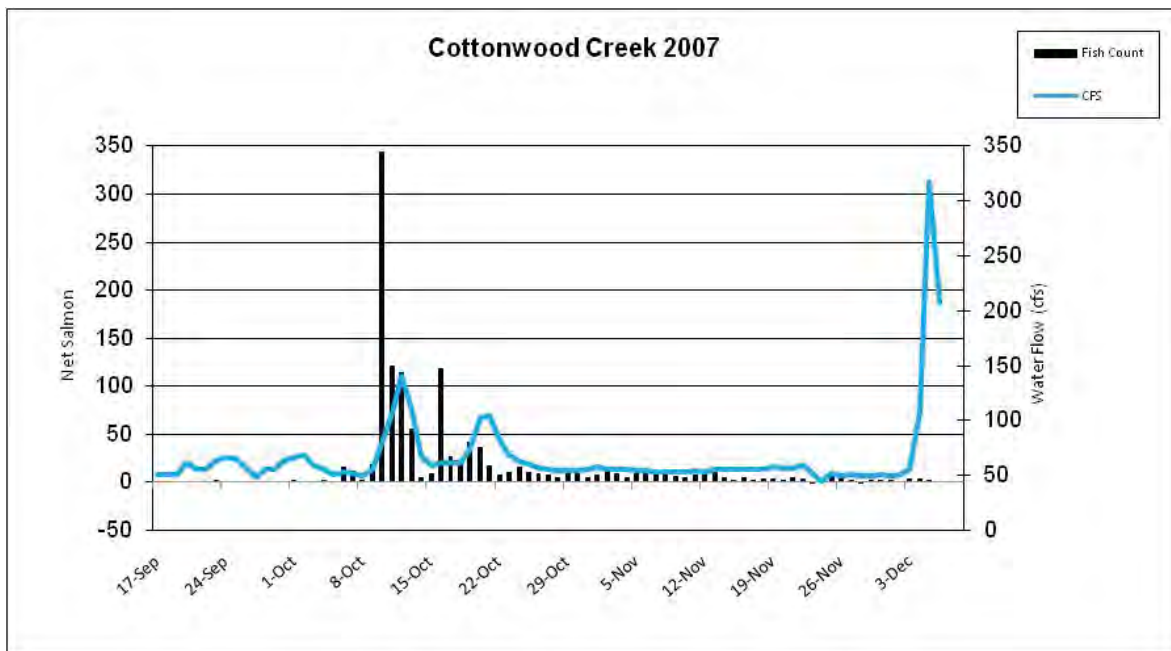
Figure 12. 2007 Total Daily Chinook Salmon Movement vs. Water Flow (cfs); Cottonwood Creek, Shasta County

The Cottonwood Creek station was operational for three consecutive years starting in fall 2007. The weir was generally operational in mid September and removed in December. Figures 12 through 14 show flow rates very likely helped influence fish passage, and few fish crossed the weir until flow rates were above 79 cubic feet per second (cfs). Irrigation diversions typically end in mid-October and a combination of increased water flow and decreasing temperatures (Appendix A) cause the initial spike in fish counts. The “y” axes are different on Figures 12 through 14 to allow for easier viewing of data due to the varying numbers of fish from year to year.

The Cottonwood Creek video weir station operated from September 17 to December 6, 2007. Dates and times when video weirs were down can be found in Appendix B. The 2007 final adjusted estimate of fall-run Chinook salmon that entered Cottonwood Creek was **1,250** (an adjusted count of 1,214 plus an additional 36 salmon that spawned immediately downstream of the station site. This additional number was based on the assumption that the 18 observed redds in that location represented 2 salmon per redd). The peak day count occurred on October 10, 2007 with 344 fish passing, a mean water temperature of 62.6° F (60.7-65.0°F), and a water flow of 79 cfs (Appendix C). The daily fish passage data and corresponding water flow in cfs are depicted in Figure 12.

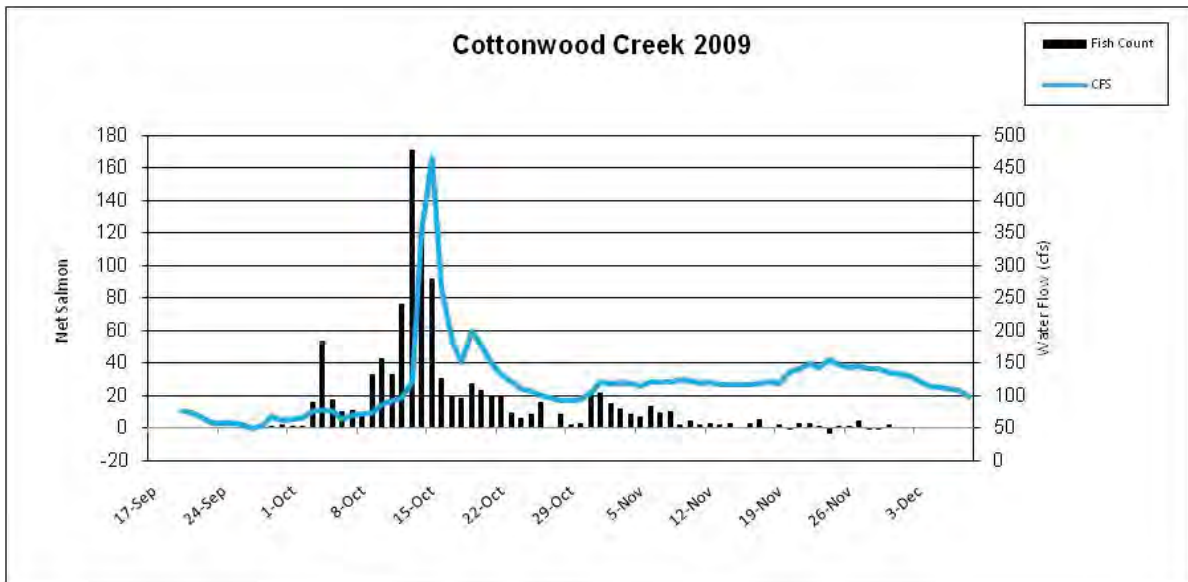
Figure 14. 2009 Total Daily Chinook Salmon Movement vs. Water Flow (cfs); Cottonwood Creek, Shasta County

The video station was operational from September 21 to December 21, 2009. Dates and times when video weirs were down can be found in Appendix B. The 2009 final adjusted estimate of fall-run Chinook salmon entering Cottonwood Creek was **1,065** (an adjusted count of 1,055 plus an additional 10 salmon that spawned immediately downstream of the station site. This additional number was based on the assumption that the 5 observed redds in that location represented 2 salmon per redd). The peak day count occurred on October 13, 2009 with 171 fish passing, a mean water temperature of 62.9°F (60-66°F), and a water flow of 120 cfs (Appendix C). The daily fish passage data and corresponding water flow in cfs are depicted in Figure 14.

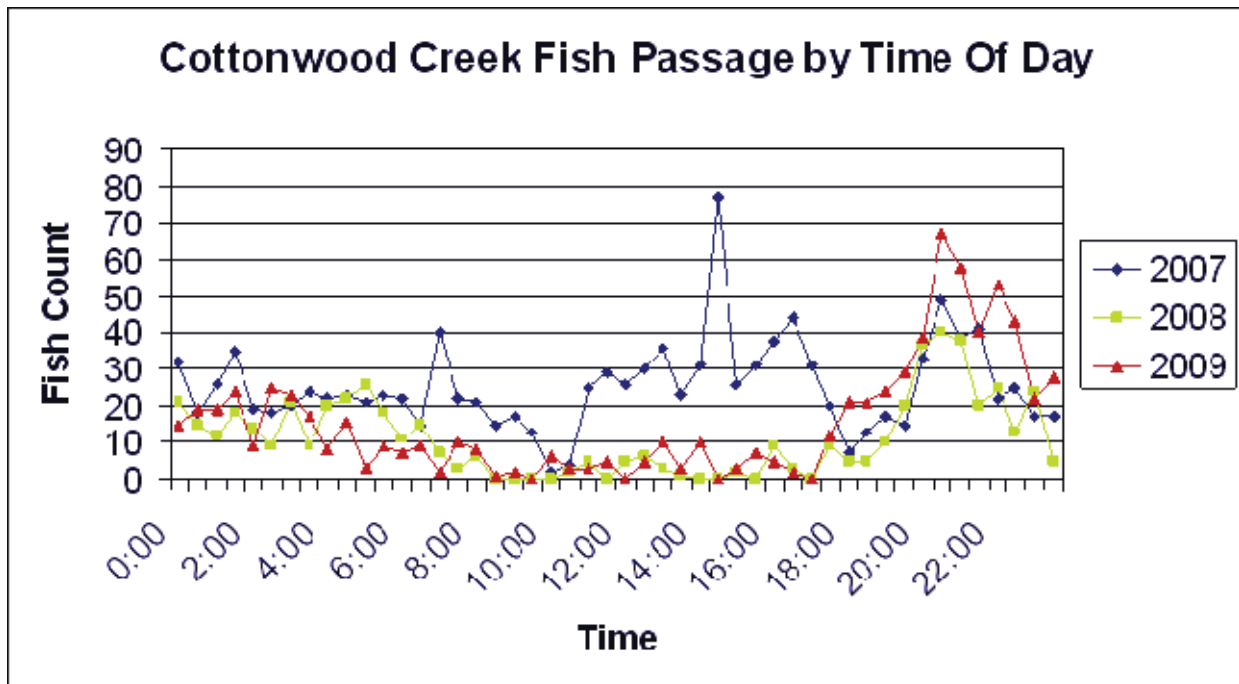
Figure 15. 2007-2009 Total Daily Chinook Salmon Movement by Time Of Day; Cottonwood Creek, Shasta County

Because the weir plate was lighted 24 hours per day, a tally of fish movement by time of day was possible as shown by Figure 15. It appears fish movement was similar in 2008 and 2009, but it has little correlation to 2007. Without additional years of sampling data, it would be difficult to determine with certainty if there is a correlation between fish movement and time of day. What was observed in these three years was that peak movement during 2007 occurred between 12:00 noon and 6:00 PM while peak movement during 2008 and 2009 occurred between 6:00 PM and 11:00 PM.

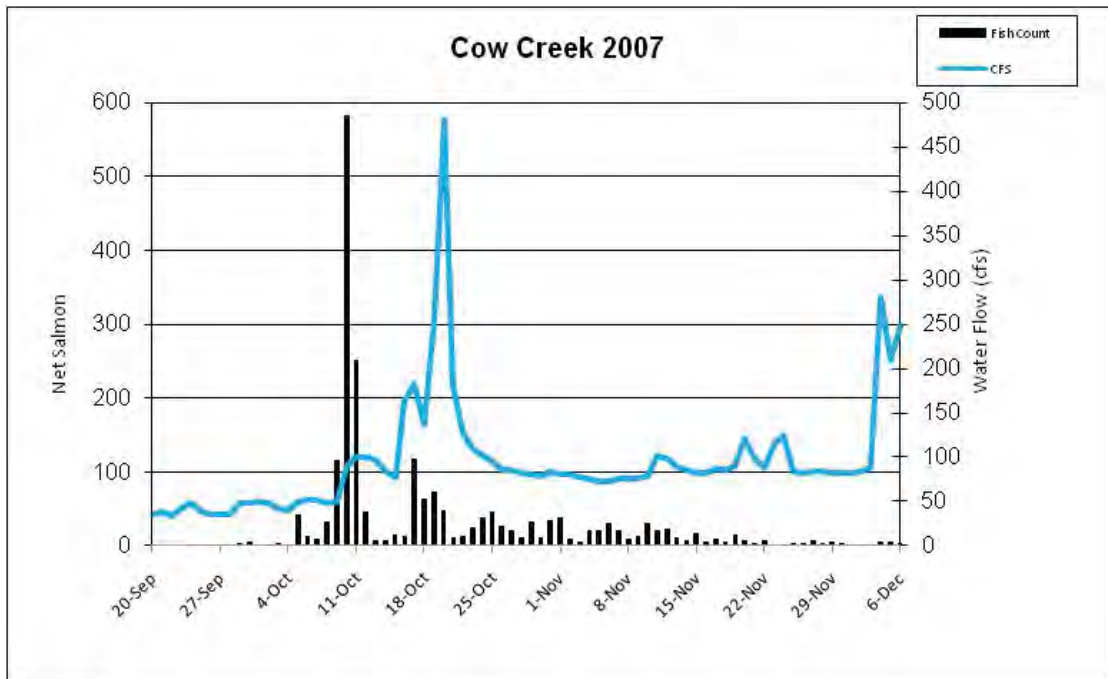
Figure 16. 2007 Total Daily Chinook Salmon Movement vs. Water Flow (cfs); Cow Creek, Shasta County

The video station was operational between September 20 and December 6, 2007. Dates and times when video weirs were down can be found in Appendix B. The 2007 final adjusted estimate of fall-run Chinook salmon that entered Cow Creek was **2,044** (an adjusted count of 2,038 plus an additional 6 salmon that spawned immediately downstream of the station site. This additional number was based on the assumption that the 3 observed redds in that location represented 2 salmon per redd). The peak day count occurred October 10, 2007 with 581 fish passing, a mean water temperature of 60.2°F (58.8-

61.9°F), and a water flow of 90 cfs (Appendix C). The daily fish passage data and corresponding water flow in cfs are depicted in Figure 16.

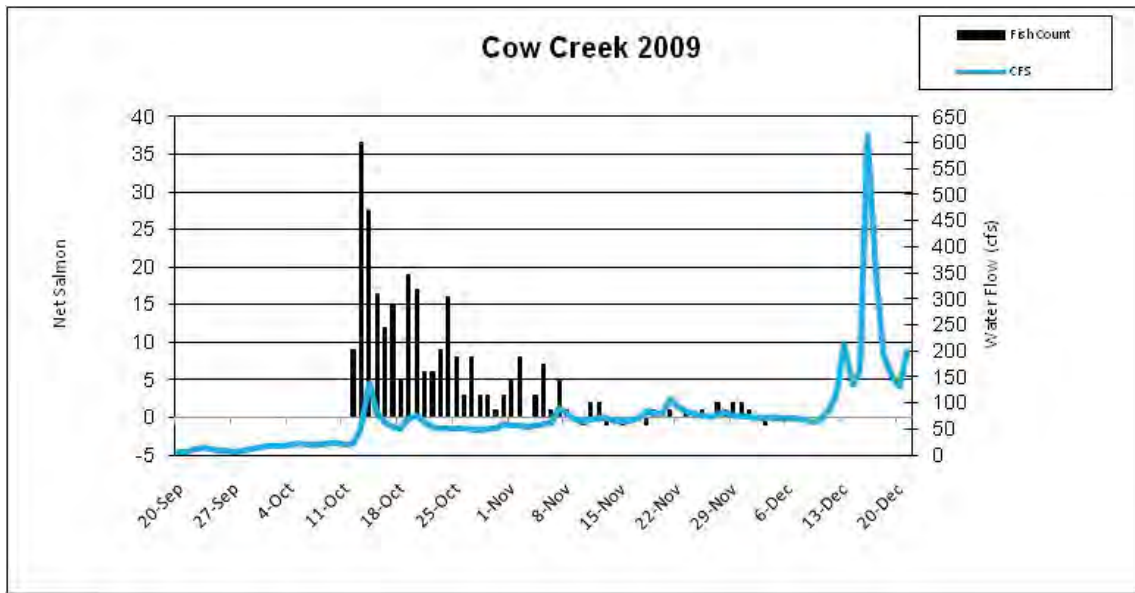
Figure 18. 2009 Total Daily Chinook Salmon Movement vs. Water Flow (cfs); Cow Creek, Shasta County

The video station was operational between September 23 and December 21, 2009. Dates and times when video weirs were down can be found in Appendix B. The 2009 final adjusted estimate of fall-run Chinook salmon that entered Cow Creek was **265** (there were no salmon redds downstream of the weir in 2009). The peak day count occurred on October 13, 2009 with 37 fish passing, a mean water temperature of 58.7°F (57.7-59.7°F), and a water flow of 50 cfs (Appendix C). The daily fish passage data and corresponding water flow in cfs are depicted in Figure 18.

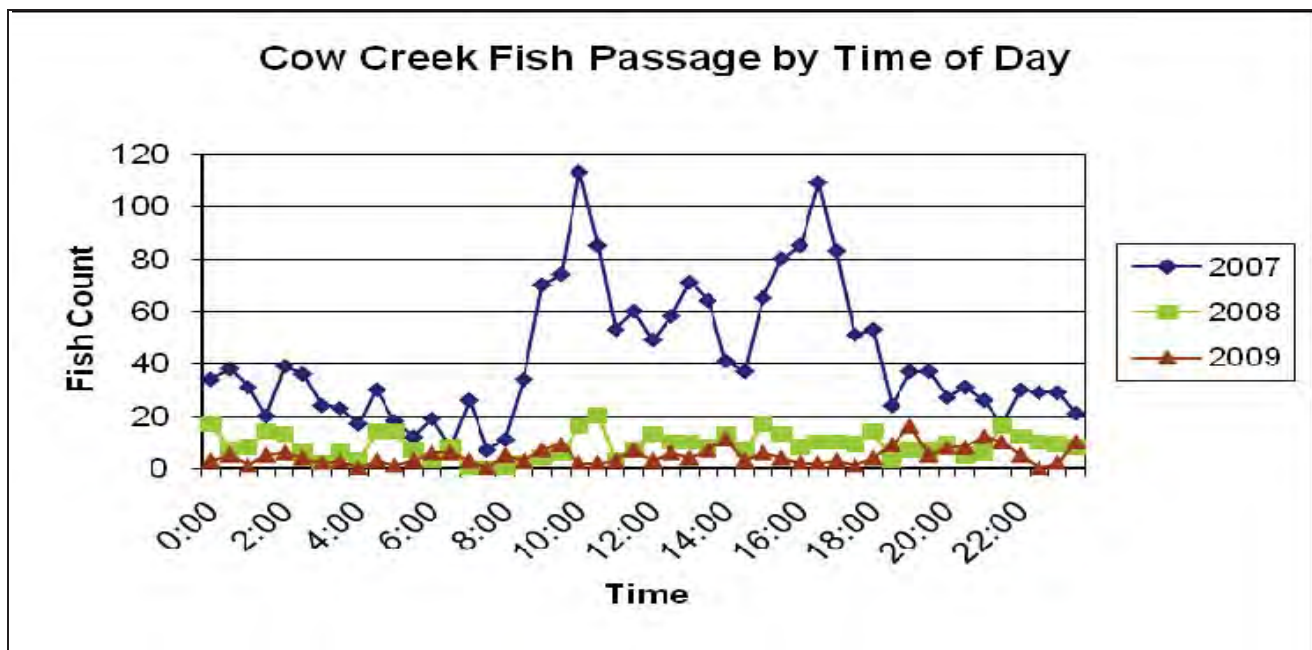
Figure 19. 2007 - 2009 Total Daily Chinook Salmon Movement by Time Of Day; Cow Creek, Shasta County

Because the weir plate was lighted 24 hours per day, a tally of fish movement by time of day was possible as shown by Figure 19 below. A casual observation of the graph shows no obvious pattern over three years. Without additional years of sampling data, it would be difficult to determine with certainty if there is a correlation between fish movement and time of day. What was observed in these three years was that peak movement during 2007 occurred during daylight hours, which was similar in Cottonwood Creek. There did not appear to be a correlation between movement and time of day during 2008 and 2009.

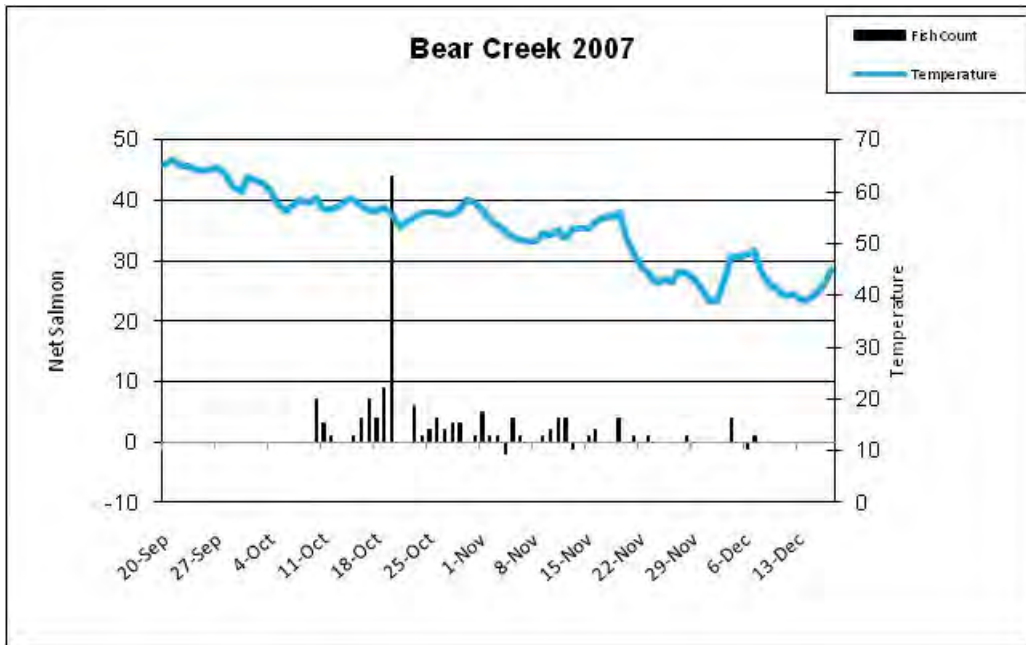
Figure 20. 2007 Total Daily Chinook Salmon Movement vs. Temperature (°F); Bear Creek, Shasta County

Bear Creek did not have flow data like other creeks in the study. Figures 20 through 22 show that decreasing temperatures, associated with increased flow, very likely helped influence fish passage, as was seen in Cottonwood and Cow Creeks. Irrigation diversions typically end in mid-October and a combination of increased water flow and decreasing temperatures (Appendix A) caused the initial spike in fish counts. The "y" axes are different on Figures 20 through 22 to allow for easier viewing of data because of the varying numbers of fish from year to year.

The video station was operational between September 20 and December 17, 2007. The 2007 final adjusted estimate of fall-run Chinook salmon that entered Bear Creek was **140** (an adjusted count of 136 plus an additional 4 salmon that spawned immediately downstream of the station site. This additional number was based on the assumption that the 2 observed redds in that location represented 2 salmon per redd). The peak day count occurred on October 20, 2007 with 44 fish passing, a mean water temperature of 55.6°F (53.5-57.4°F). The daily fish passage data and corresponding water temperature are depicted in Figure 20. September 29 was the first day that the mean water temperature fell to 60°F.

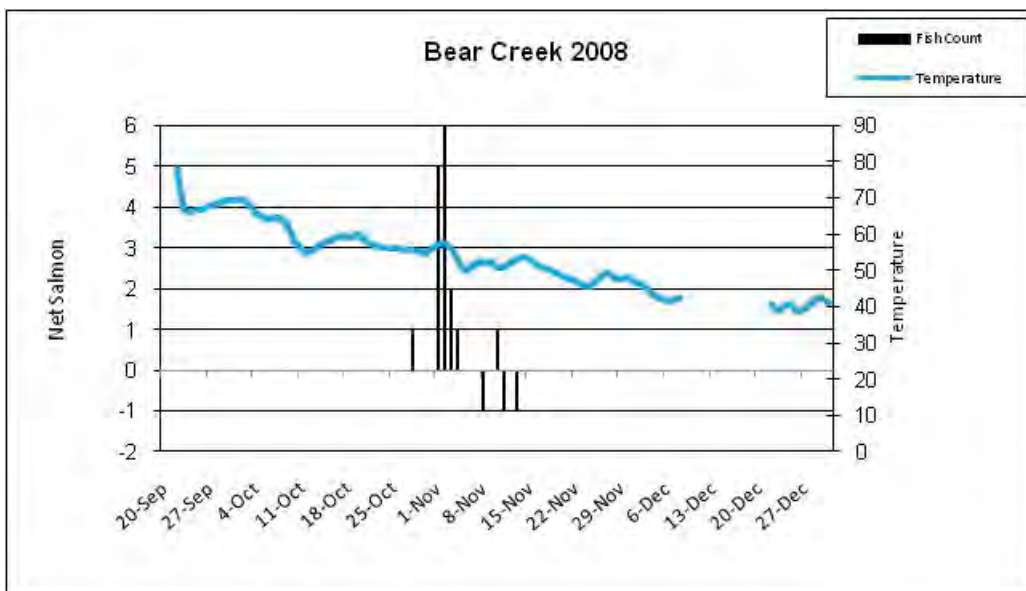
Figure 21. 2008 Total Daily Chinook Salmon Movement vs. Temperature (°F); Bear Creek, Shasta County

This year the video station was maintained through steelhead season. The video station was operational between September 23, 2008 and May 7, 2009. Dates and times when video weirs were down can be found in Appendix B. The 2008 final adjusted estimate of fall-run Chinook salmon that entered Bear Creek was **12** (there were 14 Chinook salmon counted in October and November, 2008. Two Chinook salmon were counted going downstream in March 2009, with one counted on March 5 and March 6, hence the reason for adjusting the fall-run estimate). The peak day count occurred on November 2, 2008 with 7 fish passing, a mean water temperature of 57.6°F (57.0-58.2°F). The daily fish passage data and corresponding water temperature in °F are depicted in Figure 21.
