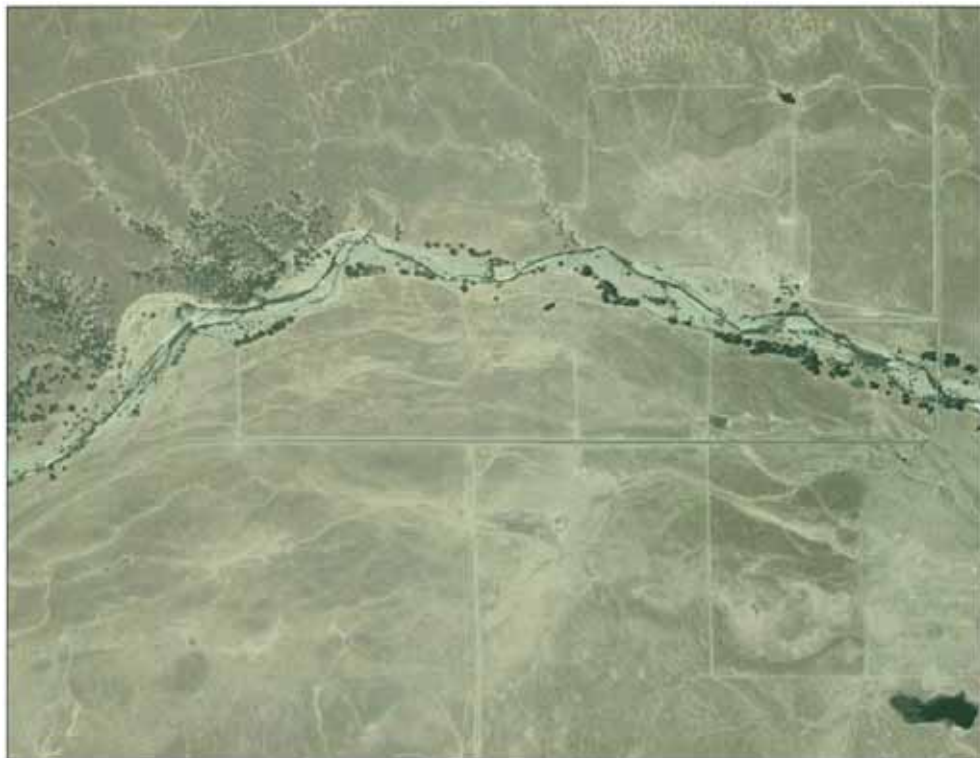
Figure 9a (top, 1947) and 9b (bottom, 2004). This is Site 6, along Elder Creek and approximately 1 mile west of the Paskenta Road. Note significant erosion features shown by the arrows. An old stream erosion feature is shown with the wavy line.

Along the northern bank of Elder Creek there are a number of significant erosion features, similar to what was seen in Sites 1-3. Sharp cut banks exist in the 1947 photograph, along with dendritic gully erosion patterns (as shown on Figure 9a). Riparian growth is very scant along Elder Creek and not present in side gullies.

In 2004 the erosion features appear less noticeable than in 1947, with the possible exception of the gully shown by the furthest east arrow on Figure 9a. Riparian growth - all of which exists directly along Elder Creek - appears mostly unchanged between 1947 and 2004. Finally, agricultural efforts appear to have been curtailed south of Elder Creek between 1947 and 2004, with only grasslands/rangelands south of Elder Creek during more recent years.
